DOT/FAA/AR-99/34

Characterization of Early Stages of Corrosion Fatigue in Aircraft Skin

Phase II: Interpretation of Corrosion-Fatigue Fracture Surfaces in Alclad 2024-T3 Aluminum Alloy Sheet

Phase II Report

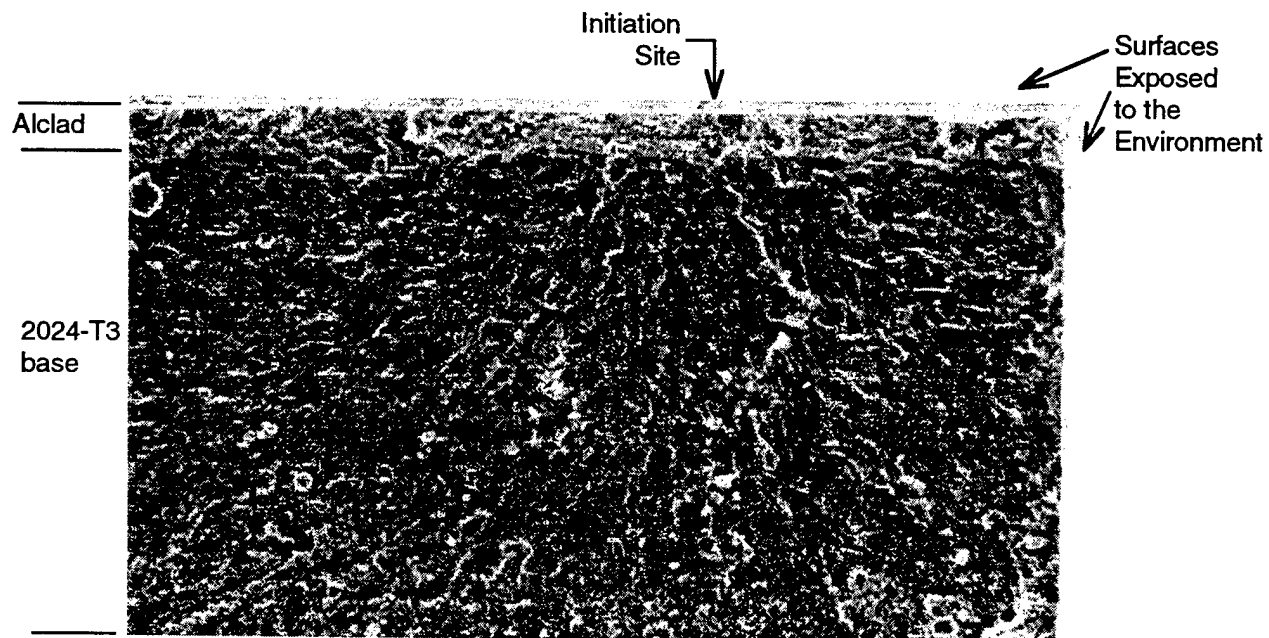
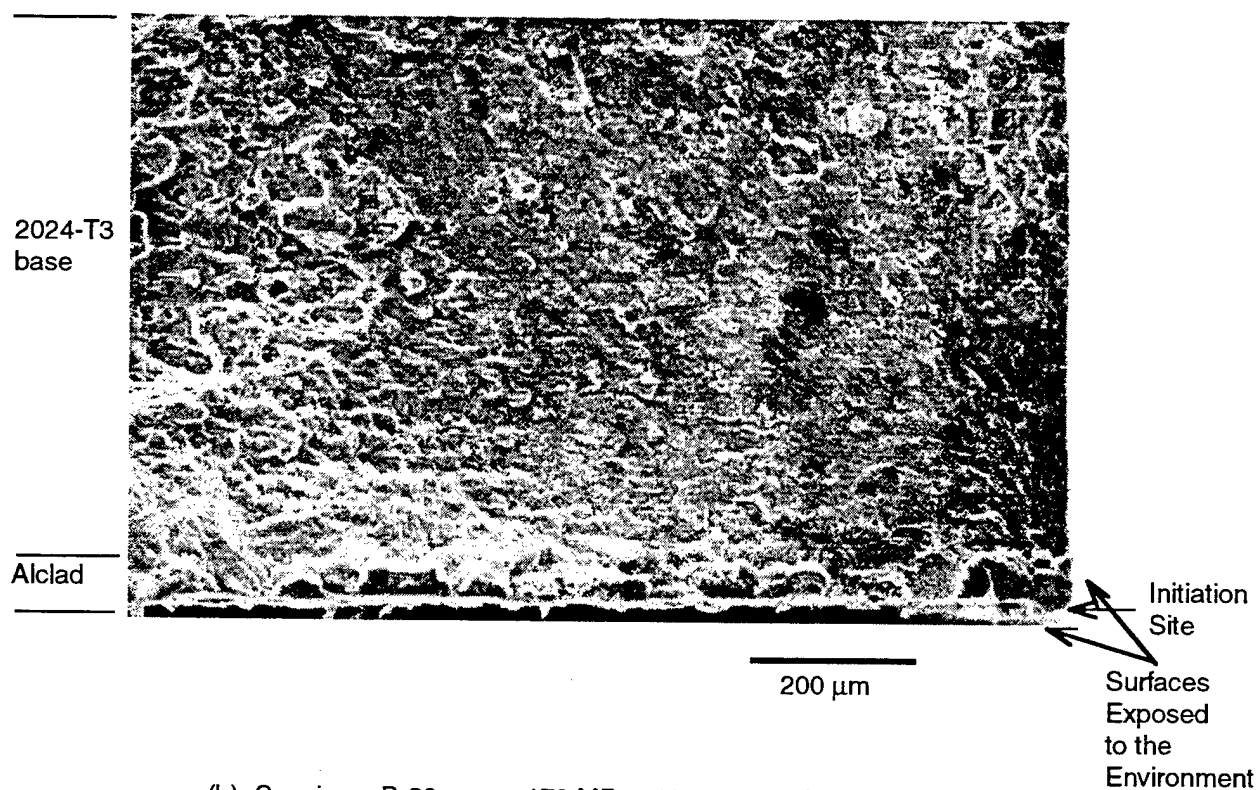
(a) Specimen B-22, $\sigma_{\text{MAX}} = 138 \text{ MPa}$, 214,108 cycles to failure.

(b) Specimen B-20, $\sigma_{\text{MAX}} = 172 \text{ MPa}$, 133,278 cycles to failure.

FIGURE 32. FRACTURE SURFACE APPEARANCE OF ALCLAD 2024-T3 FATIGUE SPECIMENS TESTED IN 0.5 M NaCl SOLUTION + 0.13 M As_2O_3 .

specimens tested under the same conditions (compare the cycles to failure of Specimen B-18 with the cycles for Specimen B-2 and B-3 in figure 32).

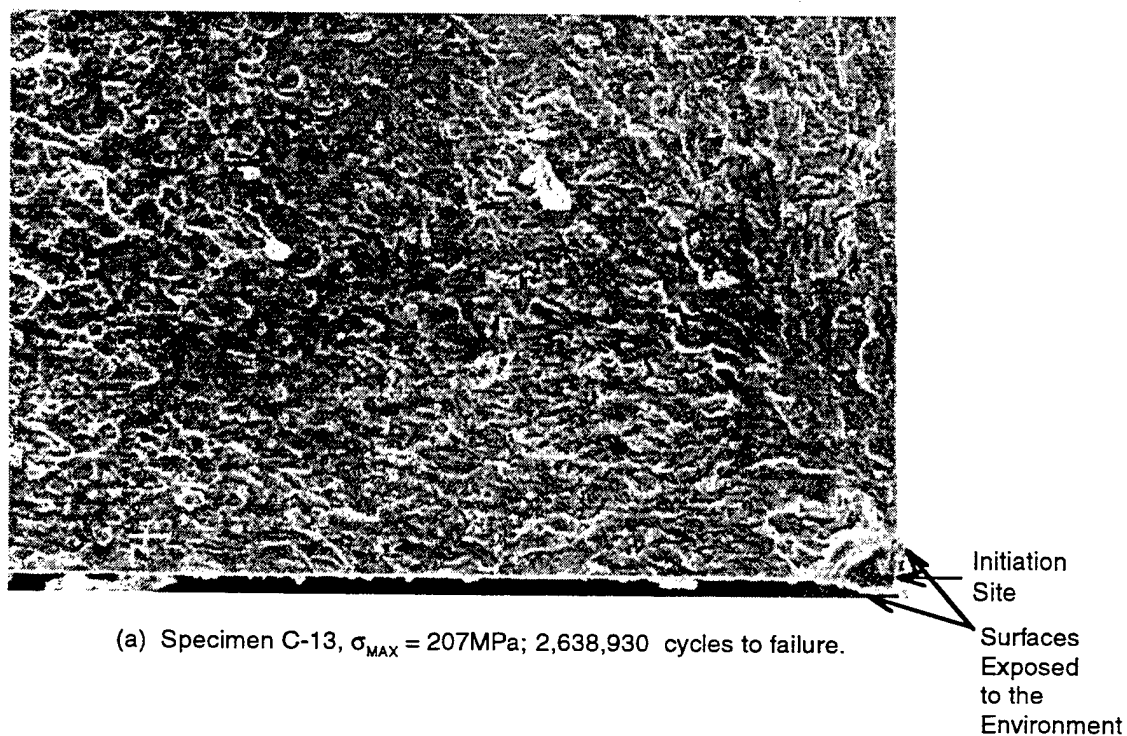
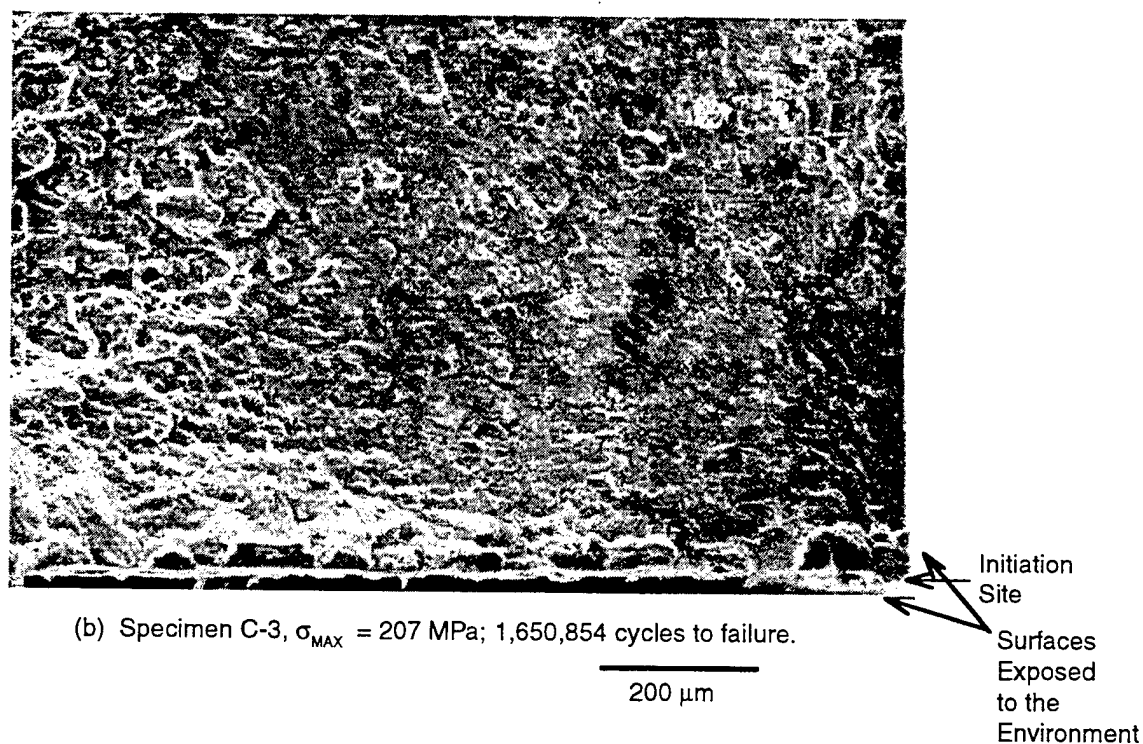
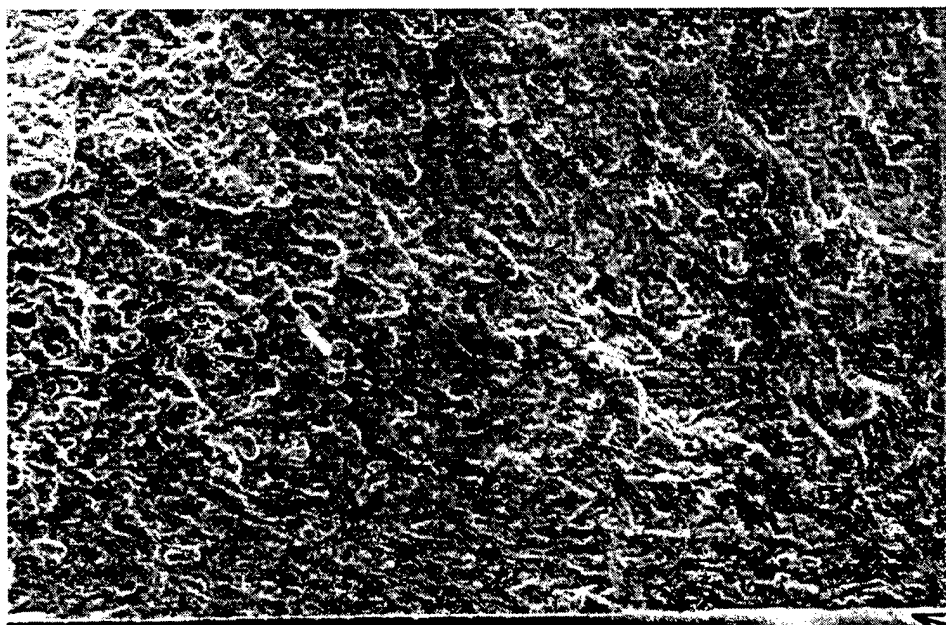
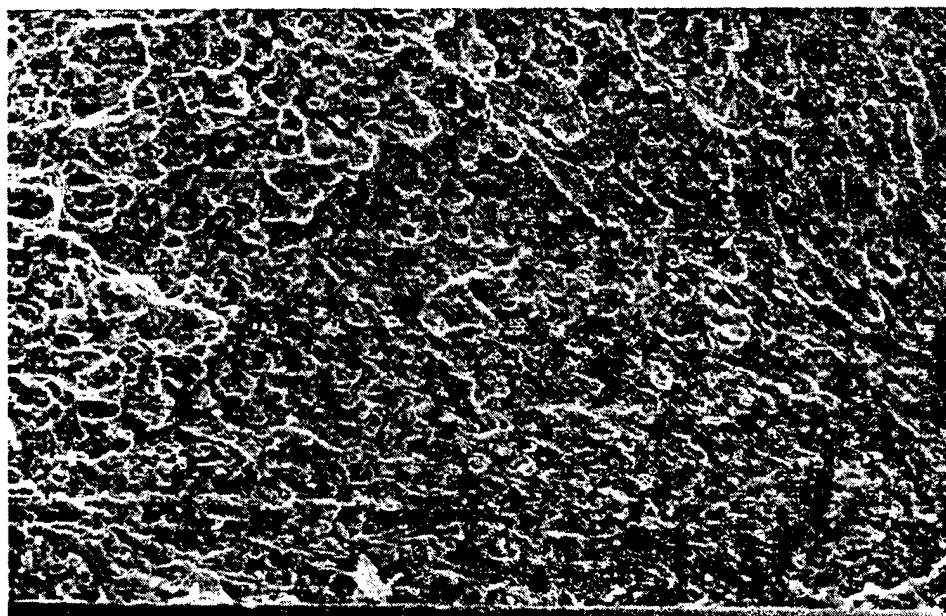
FIGURE 33. FRACTURE SURFACE APPEARANCE OF BARE 2024-T3 FATIGUE SPECIMENS TESTED IN VACUUM.

(c) Specimen C-14, $\sigma_{MAX} = 255$ MPa; 499,773 cycles to failure.

(d) Specimen C-4, $\sigma_{MAX} = 255$ MPa; 645,519 cycles to failure.

Figures 33 through 35 show the results of tests on bare material.

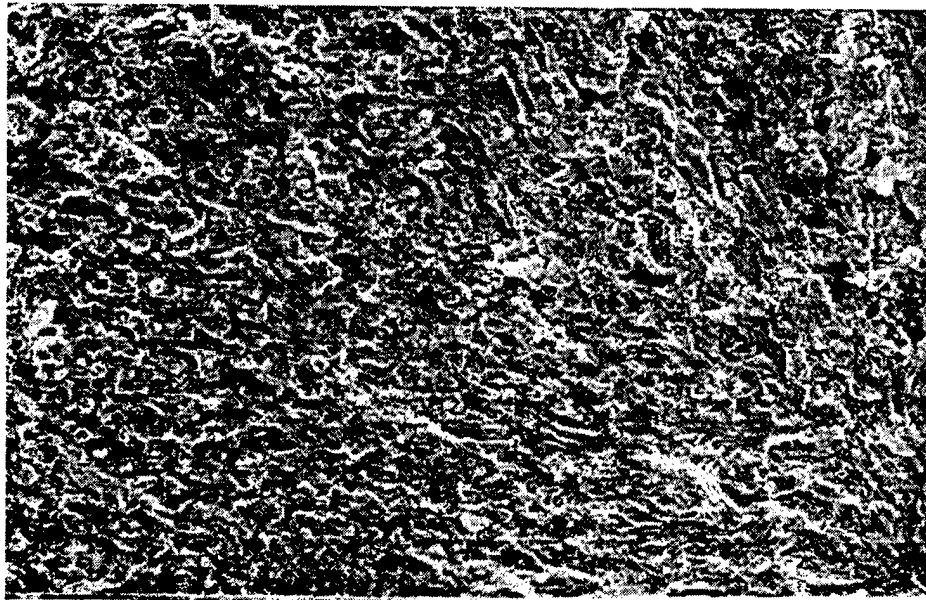
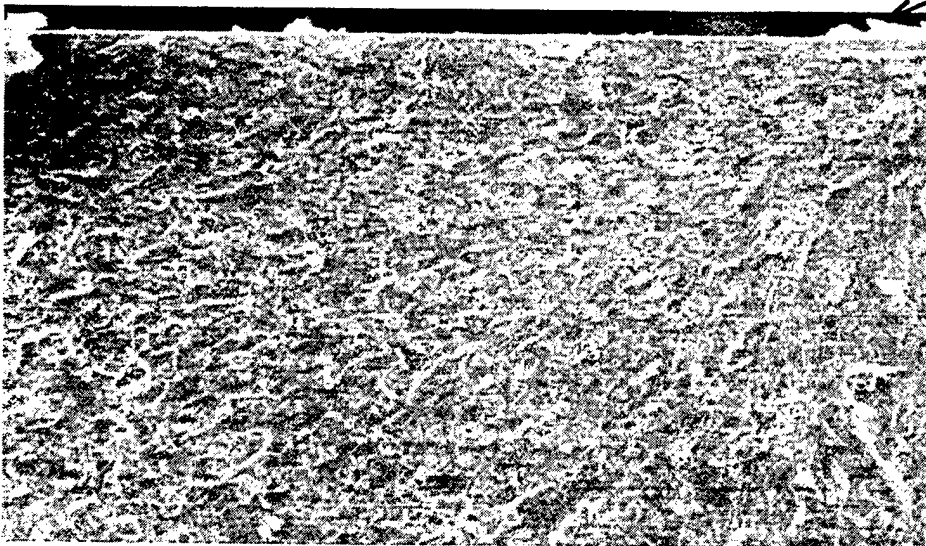
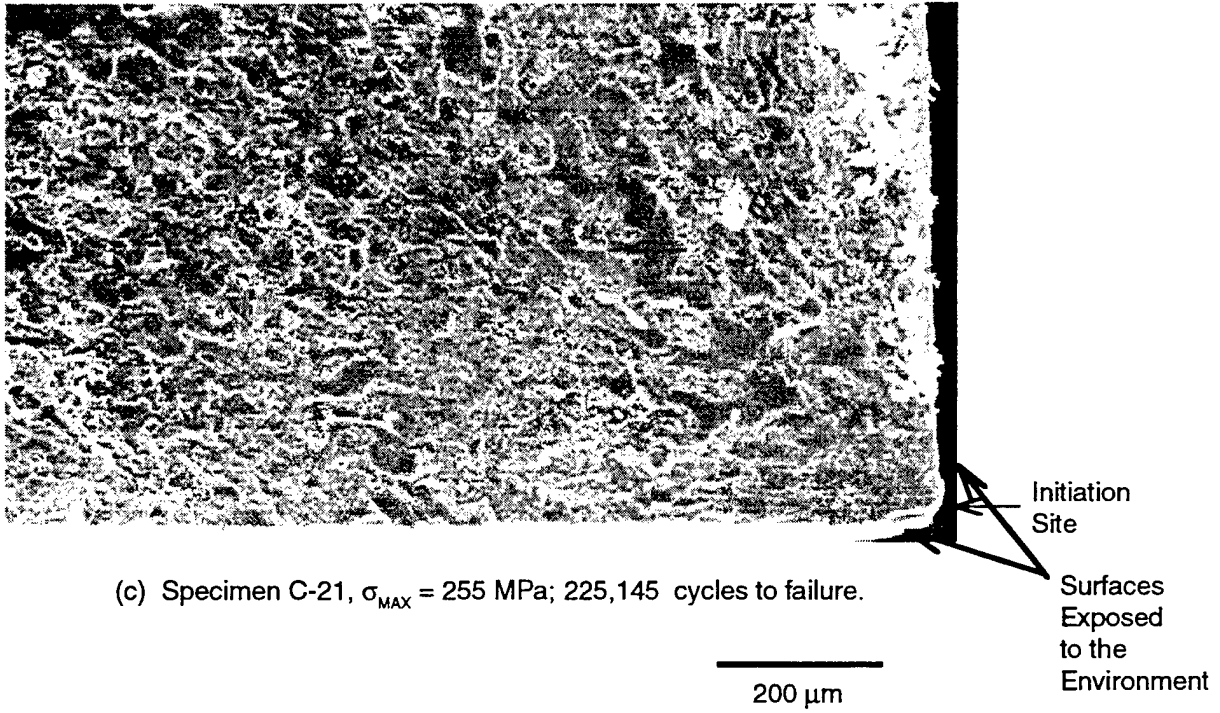
(a) Specimen C-6, $\sigma_{\text{MAX}} = 255 \text{ MPa}$; 163,866 cycles to failure.

(b) Specimen C-15, $\sigma_{\text{MAX}} = 255 \text{ MPa}$; 464,894 cycles to failure.

FIGURE 34. FRACTURE SURFACE APPEARANCE OF BARE 2024-T3 FATIGUE SPECIMENS TESTED IN AIR.
